B-4 RC橋脚主鉄筋段落とし位置での曲げせん断破壊

Flexural shear failure of reinforced concrete pier at cut-off position of the main reinforcements

■ 位置 / 3号神戸線 神P-629 (神戸市長田区)

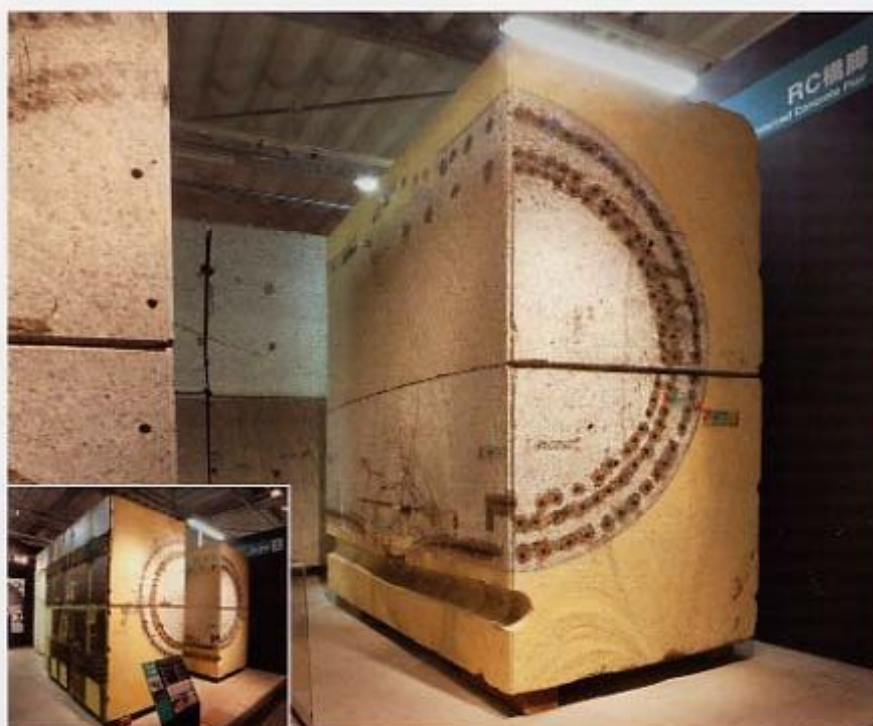
■ 損傷内容 / 柱高さ中央部の主鉄筋段落とし箇所付近において、主鉄筋が全周にわたって座屈する激しい曲げせん断損傷が生じた

■ Damage descriptions / Serious flexural shear failure was occurred at the around mid-height of the column where the longitudinal reinforcements had been cut off, causing the buckling of longitudinal reinforcement.

■ 復旧方法 / 柱基部において柱を切断・撤去し、その後、直径2.9mのRC柱を現場で構築し、工場で製作した鋼製梁を結合した

■ Restoration / The damaged column was cut at the base and removed, and subsequently a new reinforced concrete column (diameter: 2.9 m) was built on site. Finally a factory-fabricated steel beam was connected to it to complete the pier.
