震災資料保管庫

Hanshin Expressway Earthquake Museum

阪神高速道路の被害

Damage to the Hanshin Expressway

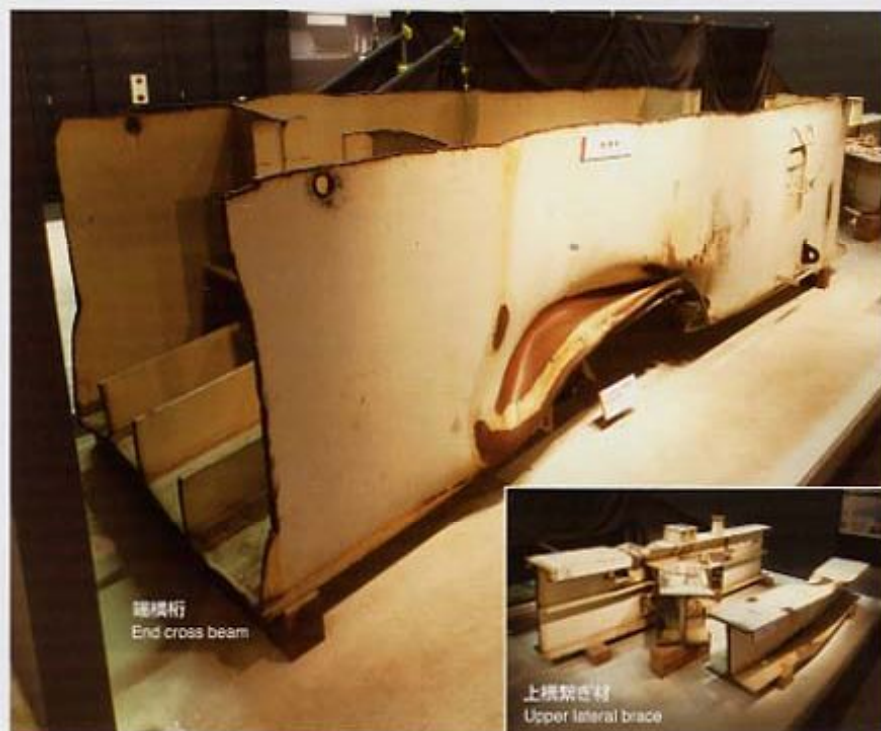
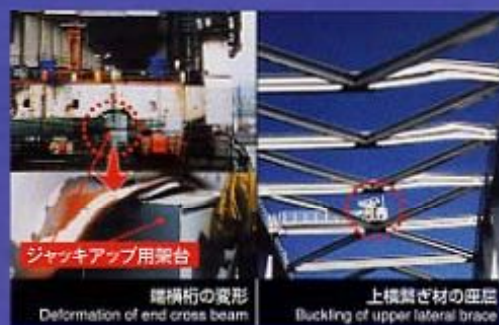
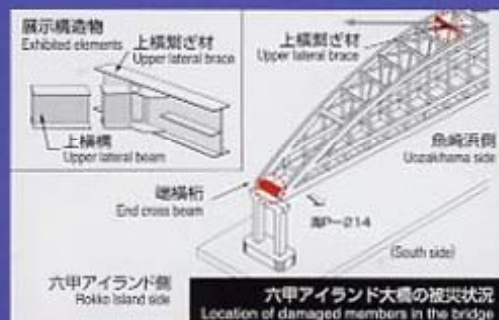
A-1 アーチ橋の上横繫ぎ材の座屈と端横桁の変形

■**損傷内容**／①六甲アイランド側の海P-214橋脚上の可動支承(ピボットローラー支承)が損傷②約9,200tの橋が東側に約3mほど水平移動③橋脚梁上に設置してあったジャッキアップ用の架台が端横桁にめり込んだ④アーチが2箇所の固定支承とジャッキアップ架台の3点支持となり、上横繫ぎ材が座屈した

■**Damage descriptions**／①A movable bearing (a pivot roller bearing) on the end pier in the Rokko Island side (P-214) was damaged.②The bridge with about 9,200 tons in weight moved about 3 m toward the east horizontally.③A jack-up support placed on the pier beam dented into the end cross beam.④The jack-up support together with two fixed bearings formed a three-point support for the arch, causing the upper lateral brace to buckle.

■**復旧方法**／2隻のクレーン船で橋全体をつり上げて元の位置に戻し、損傷した部分を新しい部材に取り替えた

■**Restoration**／ The entire bridge was lifted and replaced to its original position using two floating cranes. In addition, the damaged members were replaced with the new ones.

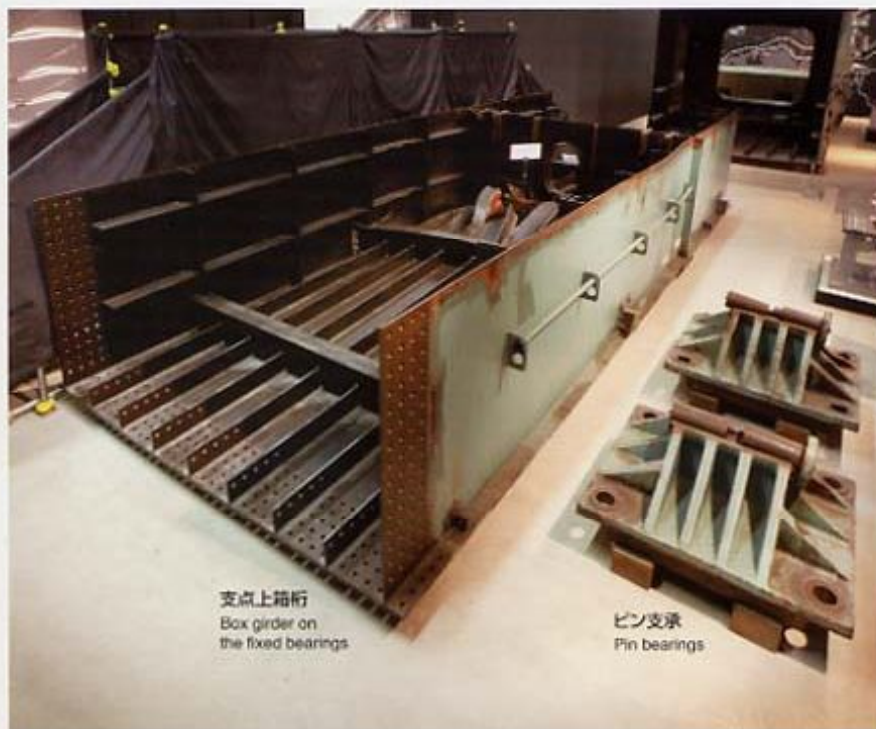
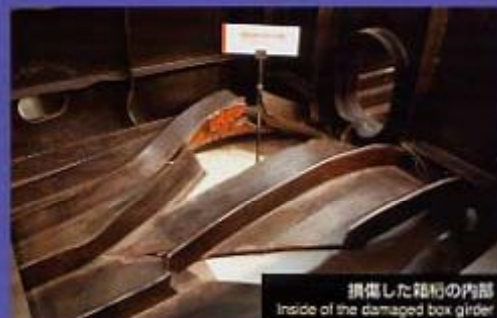
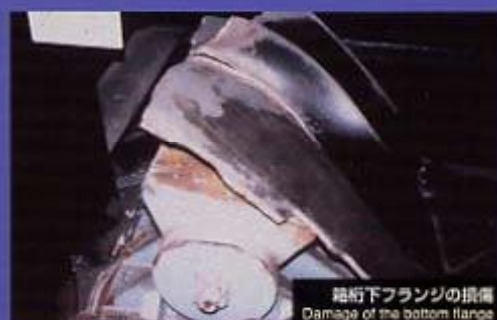
A-2 鋼連続箱桁橋の中間支点部の変形

■ 損傷内容 / ①神P-120橋脚上の固定支承(ピン支承)の上巻とピンが下巻からはずれた②水平方向の力により、上部工(箱桁)が、神戸側に約65cm、海側に約1m10cm移動した③破損したピン支承の下巻が、荷重を支えるための補強をしていない部分の箱桁下フランジを突き破った

■ Damage descriptions / ①Upper shoes and pins disengaged from the lower shoes in the fixed bearings (pin bearings) on the central pier (P-120). ②The box girders in the superstructure moved about 65 cm toward the east (Kobe side) and about 110 cm toward the south due to the horizontal force. ③The lower shoes of the damaged pin bearings broke through a bottom flange of the box girder where the load carrying reinforcement was not provided.

■ 復旧方法 / 桁下の交通規制条件を考え、損傷した部分を切り取り、新しい部材と取り替えた

■ Restoration / With traffic restrictions imposed on road below the bridge taken into account, the damaged members were cut out and removed, and subsequently new members were installed.

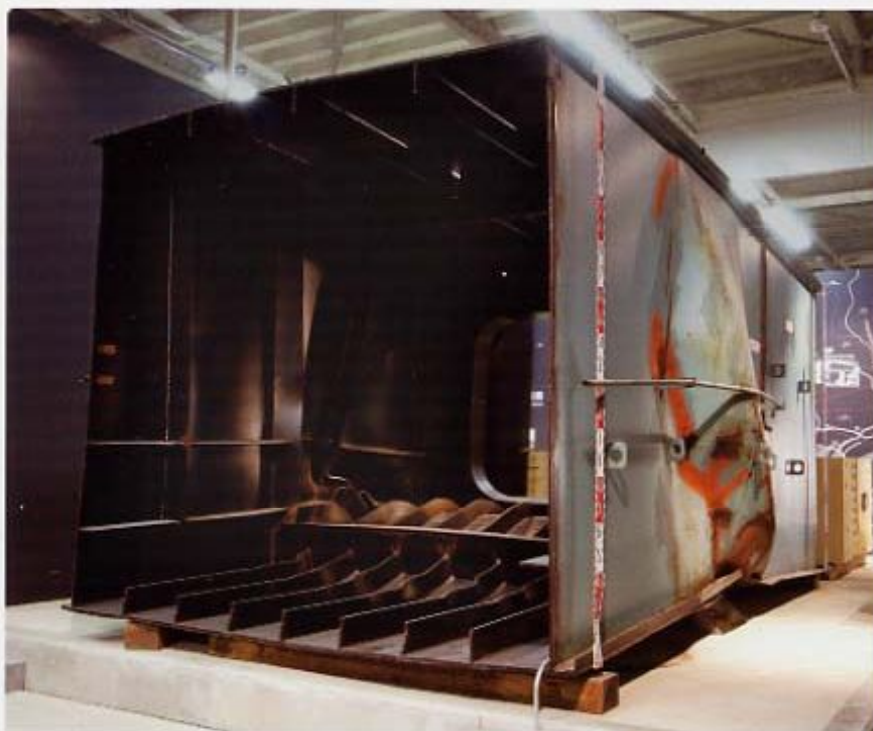
A-3 鋼連続箱桁橋の主桁の座屈

■**損傷内容**／①神S-238～240の上部工(3径間連続RC床版箱桁橋)を支持するRC橋脚4本のうち、固定橋脚の神P-240にせん断破壊が生じた②神P-240の橋脚位置のスレおよび沈下が生じた③上部工が、中間橋脚の神P-239および神P-240に近い側径間で主桁に大きな座屈が発生

■**Damage descriptions**／①The pier P-240 with a fixed bearing failed in shear among the four reinforced concrete piers which were supported the superstructure of the spans S-238 to S-240 (3-span continuous box girders with reinforced concrete decks).②The pier P-240 moved and sank from its original position.③A significant buckling occurred in the main girders of the end spans at the regions closer to the intermediate piers (P-239 and P-240).

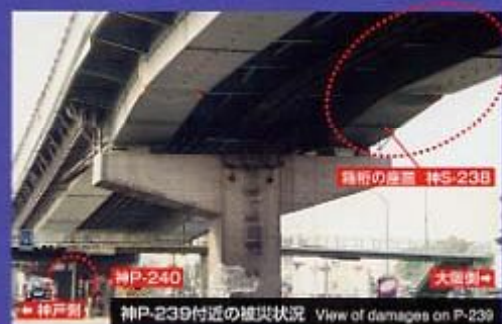
神P-239付近の被災状況 View of damages on P-239

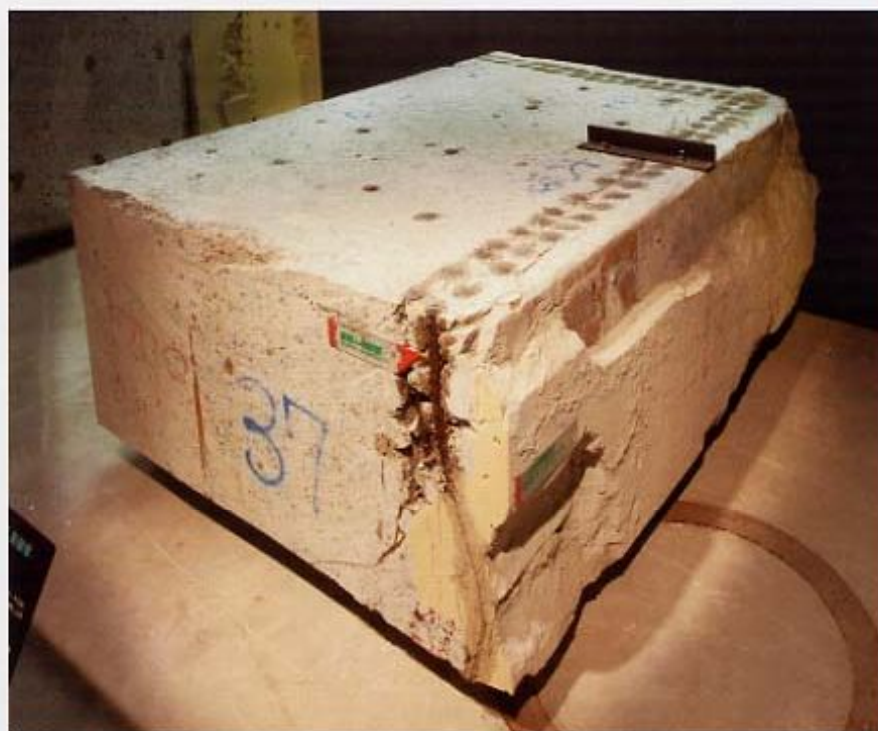
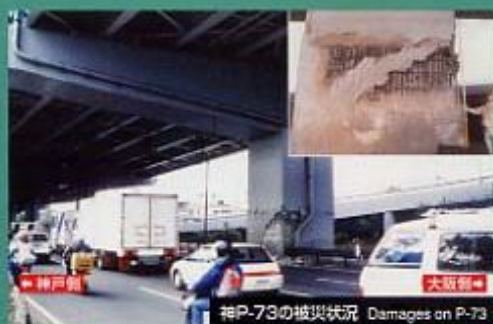
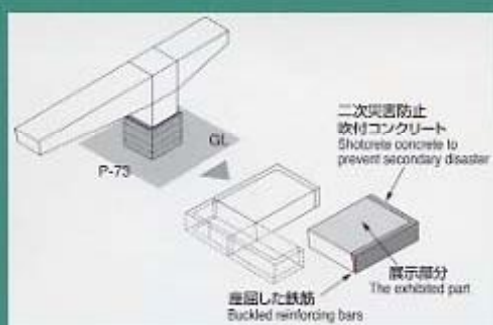
B-1 RC橋脚基部付近での曲げせん断破壊

■ 損傷内容 / 柱基部よりやや上において、曲げせん断損傷を受け、梁の張り出しが大きい海側へ柱が残留傾斜した

■ Damage descriptions / Flexural shear failure was occurred in the column at a height slightly above its base and resulted in a residual inclination toward the south in which direction the beam had large overhang.

■ Restoration / The damaged column was cut at the base and removed, and subsequently a new reinforced concrete rectangular column (3.9 m × 3.9 m) was built on site. Finally a factory-fabricated steel beam was connected on it to complete the pier.

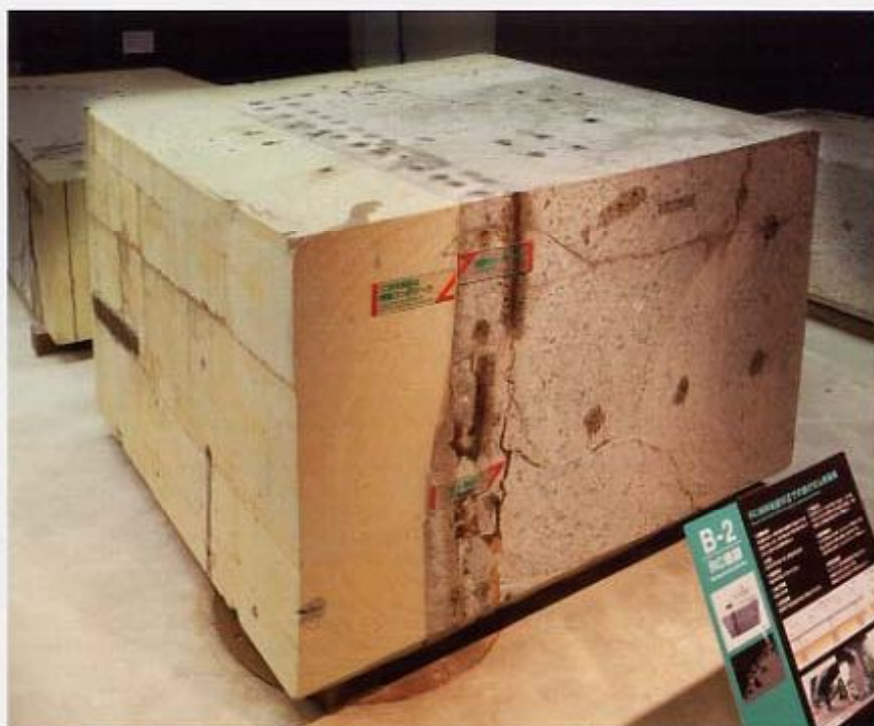
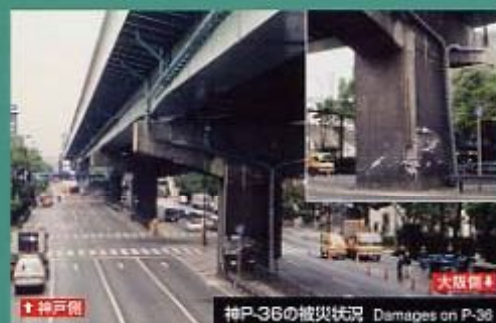
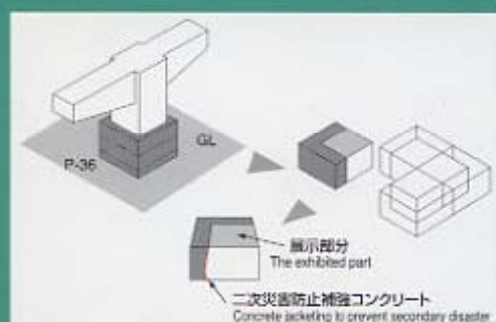
B-2 RC橋脚基部付近での曲げせん断破壊

■ 損傷内容 / 柱基部付近に一部主鉄筋が座屈する曲げせん断損傷を受け、また、神戸側および梁の張り出しが大きい山側へ柱が残留傾斜した

■ Damage descriptions / Flexural shear failure was occurred at the column base with the buckling of longitudinal reinforcement, and resulted in a residual inclination toward the east (Kobe side) and also toward the north in which direction the beam had large overhang.

■ Restoration / The damaged column was cut at the base and removed, and subsequently a new reinforced concrete rectangular column (3.9 m × 3.9 m) was built on site. Finally a factory-fabricated steel beam was connected on it to complete the pier.

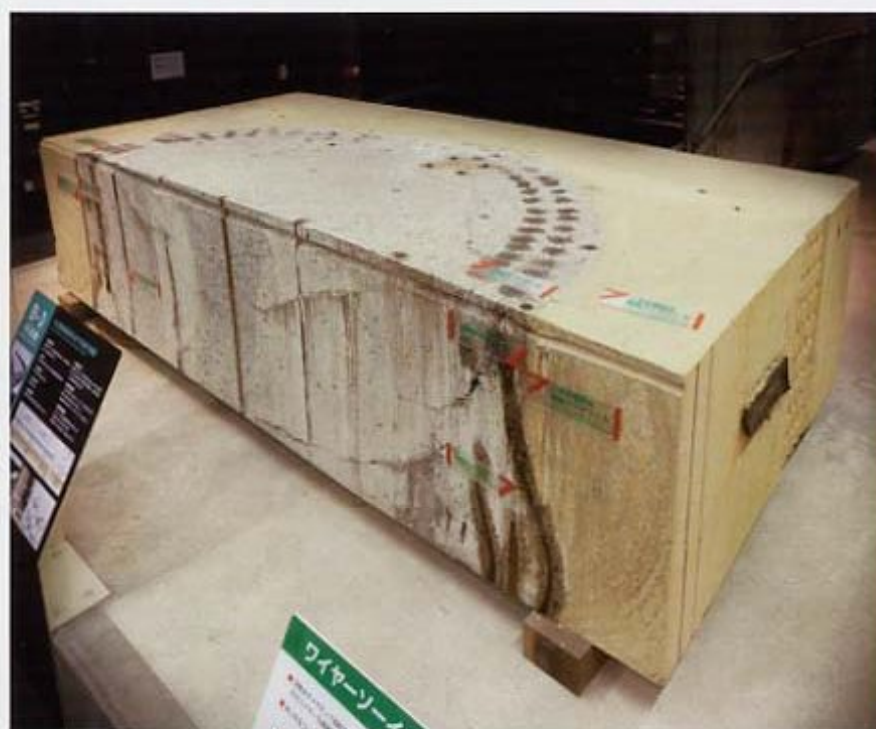
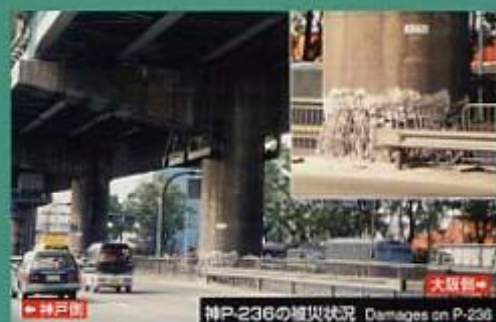
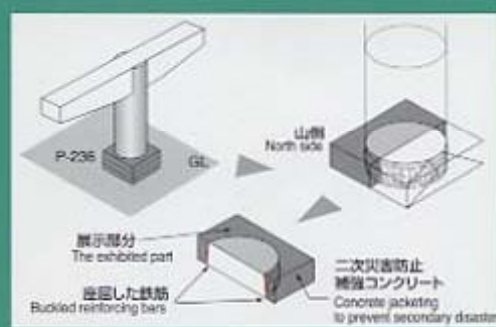
B-3 RC橋脚基部付近での曲げ破壊

■ **損傷内容** / 柱基部付近で、主鉄筋が全周にわたって座屈する激しい曲げ損傷が生じた

■ **Damage descriptions** / Serious flexural failure was occurred at the column base with the buckling of longitudinal reinforcements.

■ **Restoration** / The damaged column was cut at the base and removed, and subsequently a new reinforced concrete cylindrical column (diameter: 3.4 m) was built on site. Finally a factory-fabricated steel beam was connected on it to complete the pier.

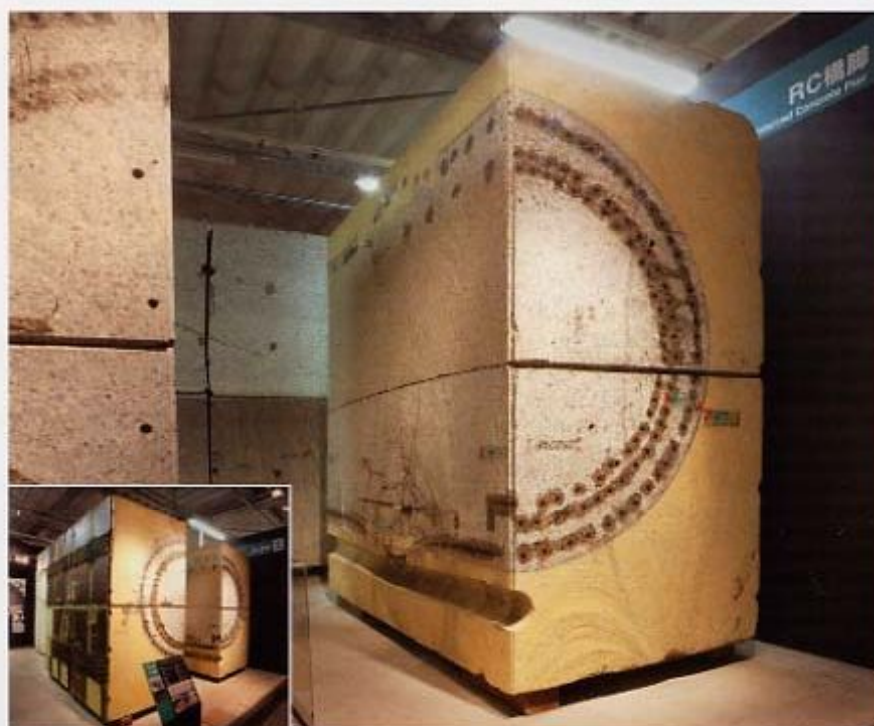
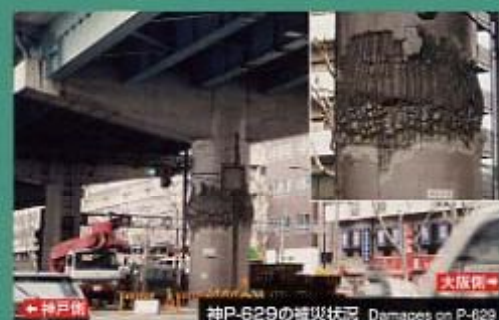
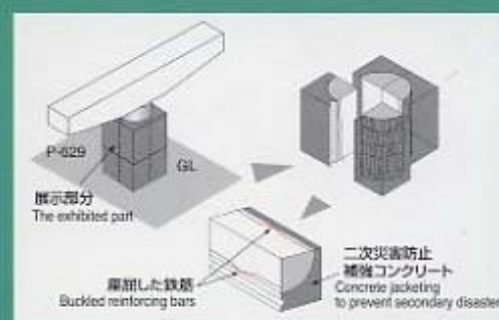
B-4 RC橋脚主鉄筋段落とし位置での曲げせん断破壊

■ 損傷内容 / 柱高さ中央部の主鉄筋段落とし箇所付近において、主鉄筋が全周にわたって座屈する激しい曲げせん断破壊が生じた

■ Damage descriptions / Serious flexural shear failure was occurred at the around mid-height of the column where the longitudinal reinforcements had been cut off, causing the buckling of longitudinal reinforcement.

■ Restoration / The damaged column was cut at the base and removed, and subsequently a new reinforced concrete column (diameter: 2.9 m) was built on site. Finally a factory-fabricated steel beam was connected to it to complete the pier.

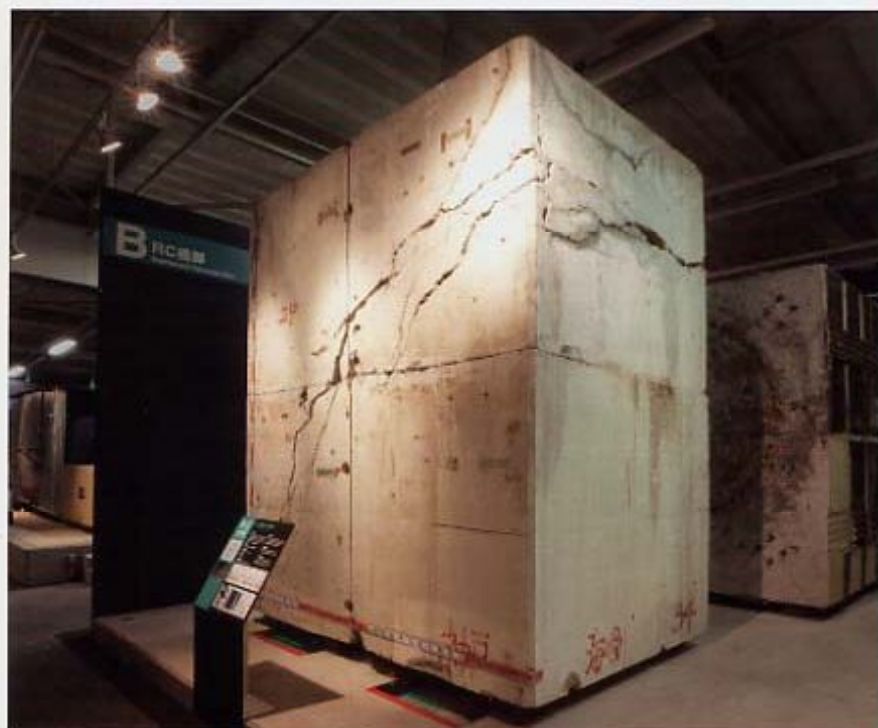
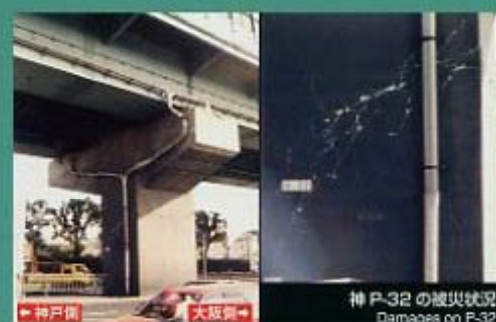
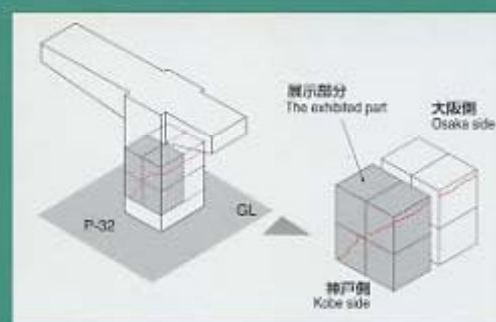
B-5 RC橋脚のせん断損傷

■ **損傷内容** / 柱基部よりやや上において、せん断損傷を受けた。外観調査では軽微な損傷と考えられていたが、詳細調査の結果、ひびわれが柱コンクリート内部にまで及んでいることが確認された

■ **Damage descriptions** / Shear failure was occurred in the column at a height slightly above its base. Although the column was determined as a minor damage during an appearance observation for the structure, it was found from a detailed inspection that cracks had reached the inner concrete of the column.

■ **Restoration** / The damaged column was cut at the base and removed, and subsequently a new reinforced concrete rectangular column (4.1 m x 5.1 m) was built on site. Finally a factory-fabricated steel beam was connected on it to complete the pier.

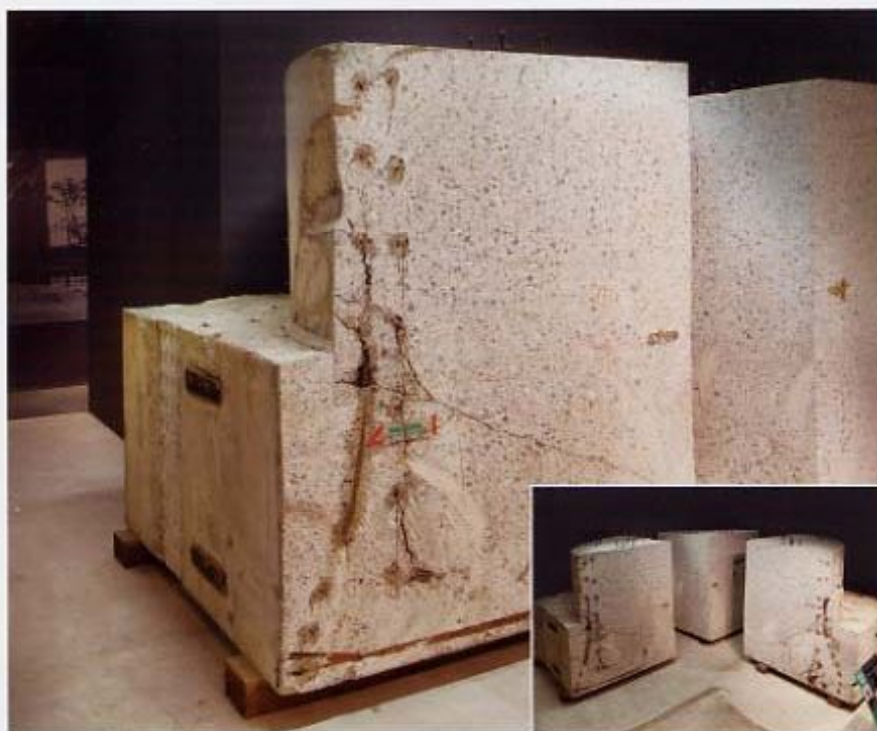
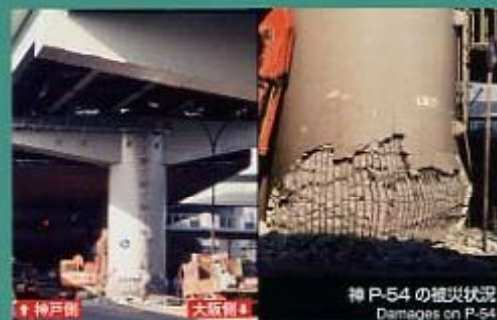
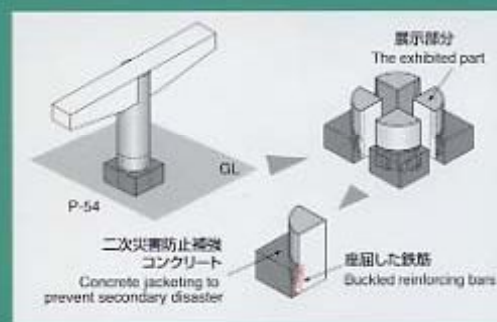
B-6 RC橋脚基部付近での曲げせん断破壊

■ 損傷内容 / 柱基部付近において、主鉄筋が全周にわたって座屈し、帯鉄筋がばらける激しい曲げせん断損傷が生じた

■ Damage descriptions / Severe flexural shear failure was occurred at the column base with the buckling of longitudinal reinforcement.

■ Restoration / The damaged column was cut at the base and removed, and subsequently a new reinforced concrete cylindrical column (diameter: 3.9 m) was built on site. Finally a factory-fabricated steel beam was connected on it to complete the pier.

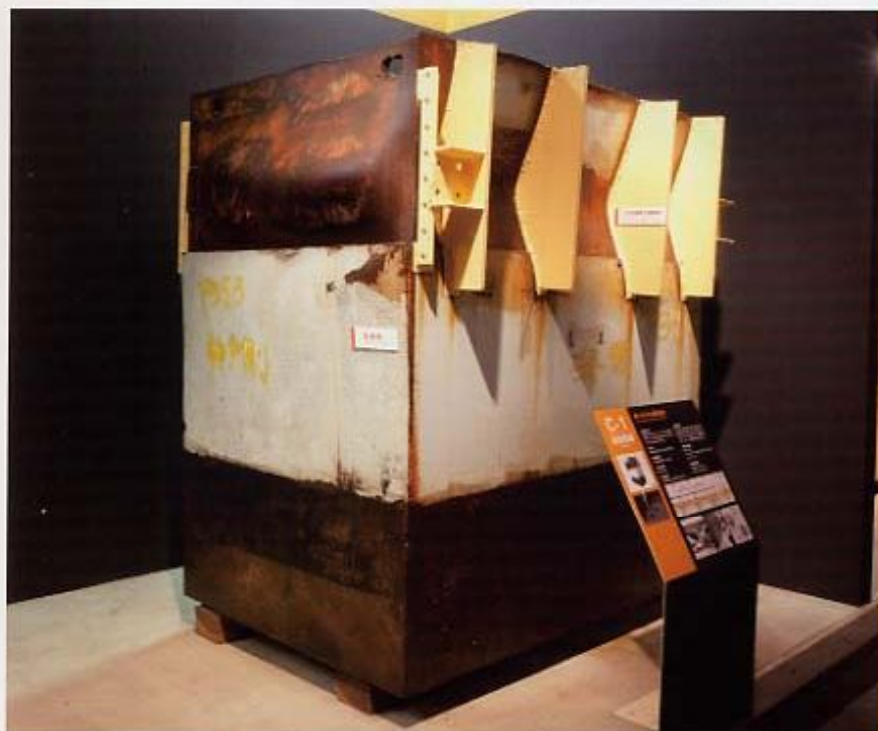
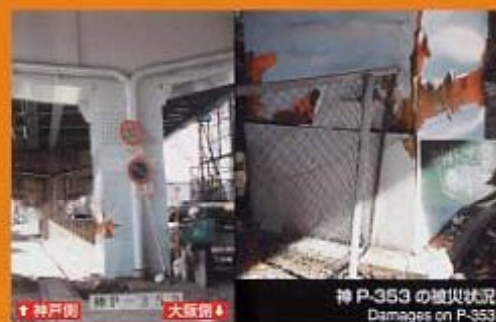
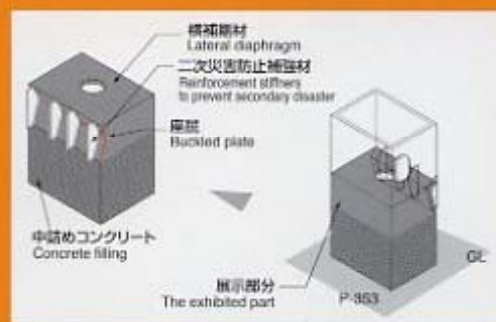
C-1 板パネルの局部座屈

■ **損傷内容** / 橋脚基部の中詰めコンクリートと直上の横補剛材間で板パネルの局部座屈が発生し、梁の張り出しが大きい海側に大きく傾斜した

■ **Damage descriptions** / Local buckling of the stiffened plate occurred between the concrete filling portion at the column base and the lateral diaphragm just above there, and resulted in a significant residual inclination toward the south in which direction the beam had large overhang.

■ **復旧方法** / 上部工および橋脚梁部を仮受けした後、損傷した橋脚基部を切断・撤去し、新しい部材(板厚30mm、材質SM490YB)と取り替えた。また、橋脚内部の中詰めコンクリートの設置範囲を従来より高くした

■ **Restoration** / After underpinning the superstructure and pier beam members, the damaged column was cut at the base and removed out, and subsequently a new member (thickness: 30 mm; material: SM490YB) was installed. The level of the concrete filling the pier was raised from the previous setting.

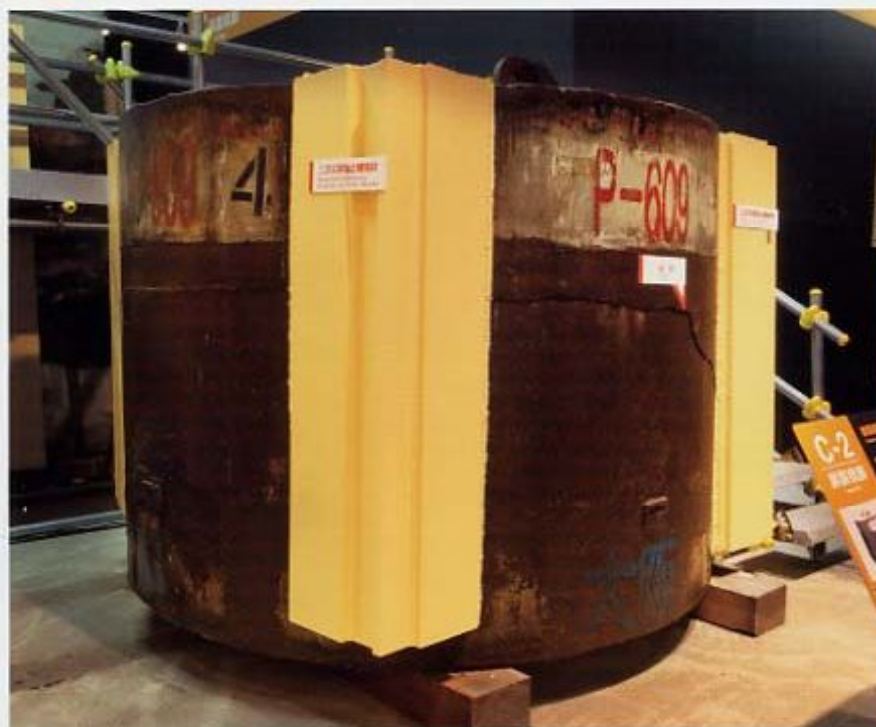
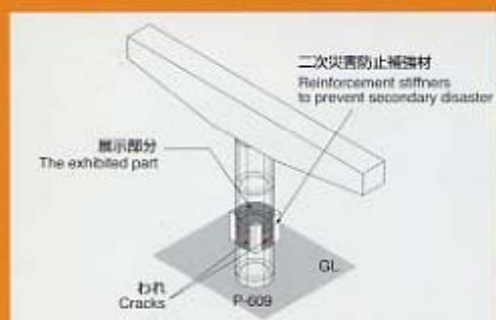
C-2 鋼製橋脚(円形)のわれ

■**損傷内容**／外観上座層はほとんど認められなかったが、横補剛材間の溶接部全周にわれが発生していた

■**Damage descriptions**／ Although almost no buckling was visible from the appearance, cracks were found in the welds between lateral diaphragms all around the pier.

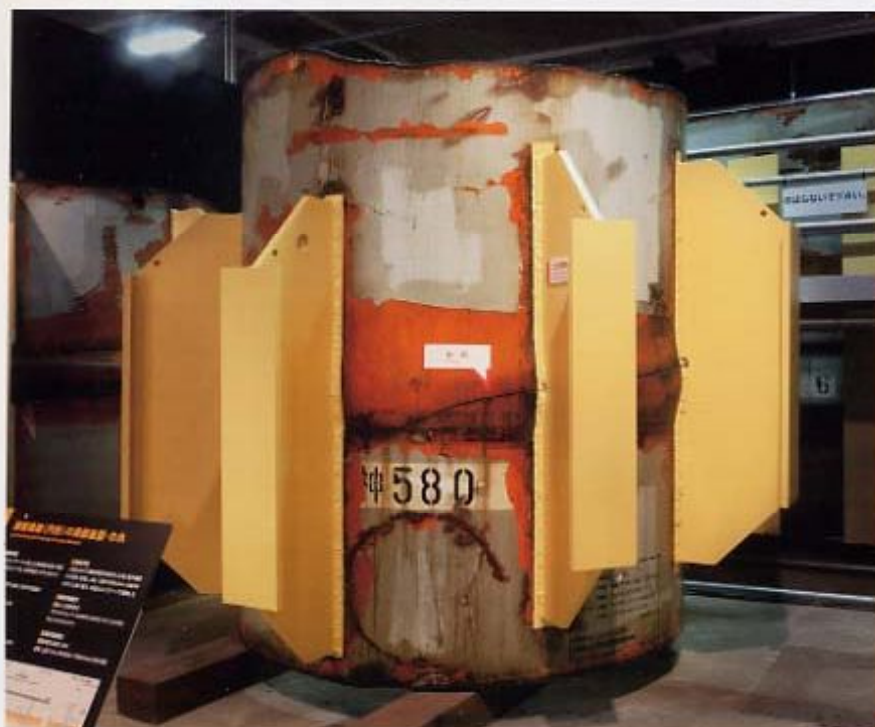
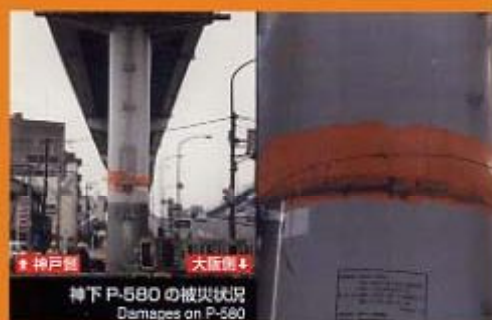
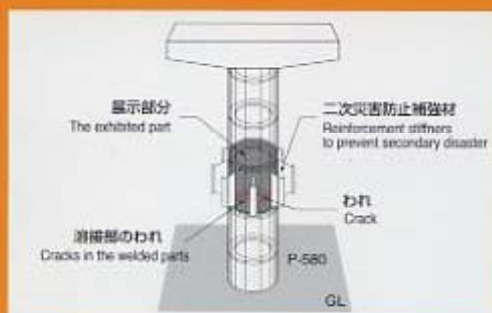
C-3 鋼製橋脚(円形)の局部座屈・われ

■**損傷内容** / 中詰めコンクリートと直上の横補剛材間に局部座屈が発生した。また、柱溶接部にわれが生じた

■**Damage descriptions** / Local buckling occurred between the concrete filling portion and the lateral diaphragm just above it. Cracks occurred in the welds on the column.

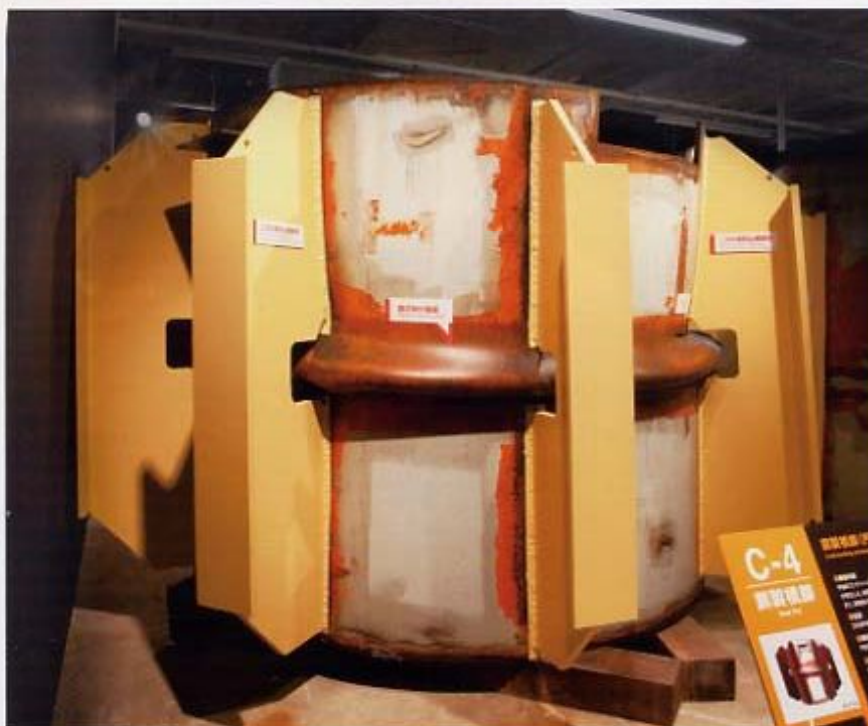
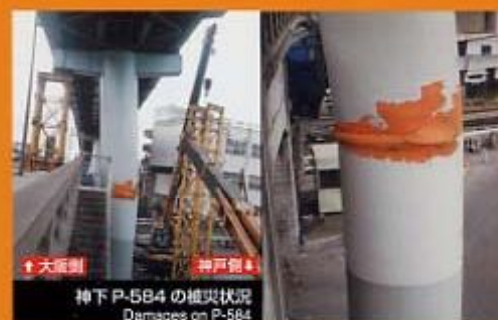
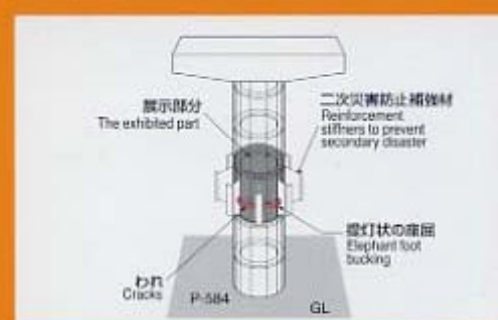
C-4 鋼製橋脚(円形)の局部座屈・破断われ

■**損傷内容** / 中詰めコンクリートと直上の横補剛材間に局部座屈が発生した。座屈した箇所は提灯のようになり、また、溶接部が破断した

■**Damage descriptions** / Local buckling occurred between the filling concrete portion and the lateral diaphragm just above it, resulting in elephant foot buckling and the rupture of the welds.

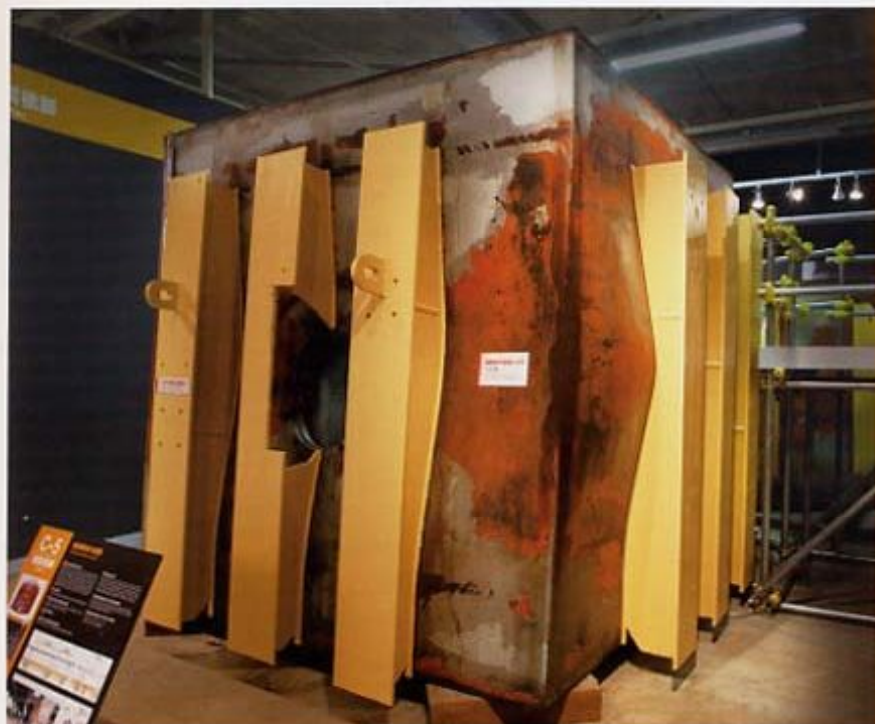
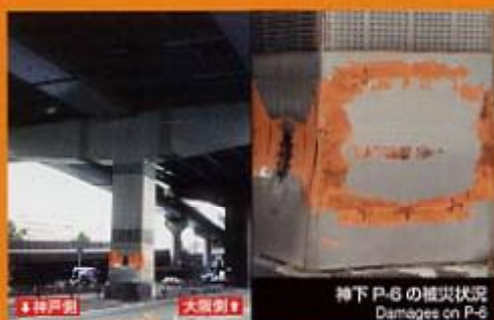
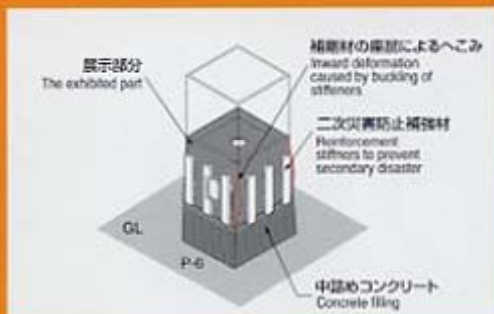
C-5 縦補剛材の座屈

■ **損傷内容** / 大部分の上部工荷重を支える海側橋脚柱において、中詰めコンクリートと直上の横補剛材間に縦補剛材全体に座屈が生じた。海側山側2面がはらみ出し、大阪側神戸側2面がへこんだ状態になった。大阪側に設置したマンホールが弱点になったと考えられる。

■ **Damage descriptions** / Buckling of the entire stiffeners occurred between the filling concrete portion and the lateral diaphragm just above it in the column of the south pier which was carrying most loads of the superstructure. The column deformed outward in the north and south faces and inward in both the east (Kobe side) and west (Osaka side) faces. A manhole provided in the Osaka side was considered to have served as a weakness in this incident.

■ **Restoration** / After underpinning the superstructure and pier beam members, the damaged column was cut at its bottom block and removed out, and subsequently a new member (thickness: 40 mm; material: SM520C) was installed. The level of the concrete filling the pier was raised to the bottom of the beam.

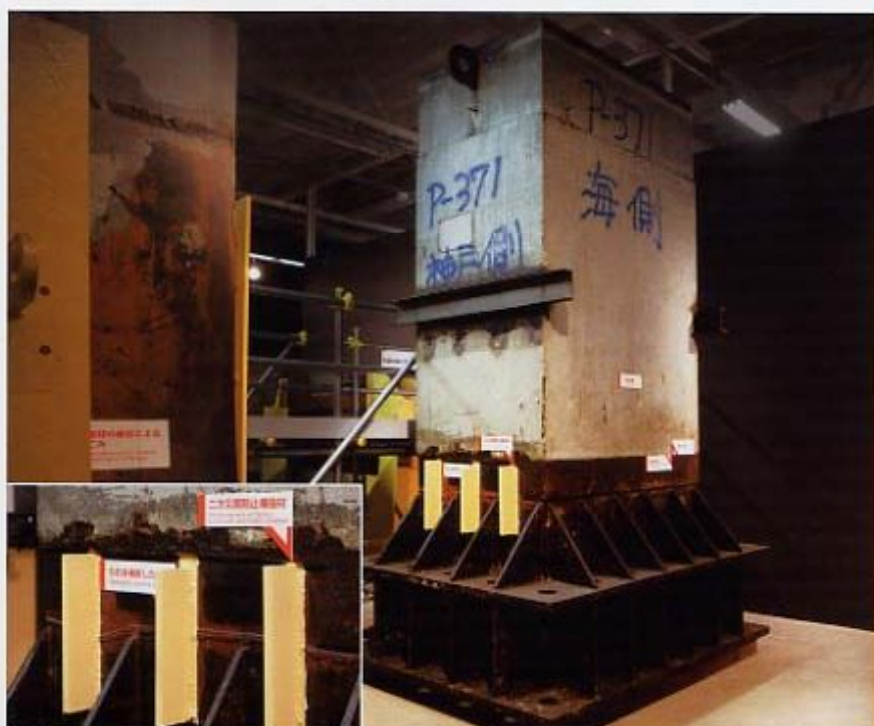
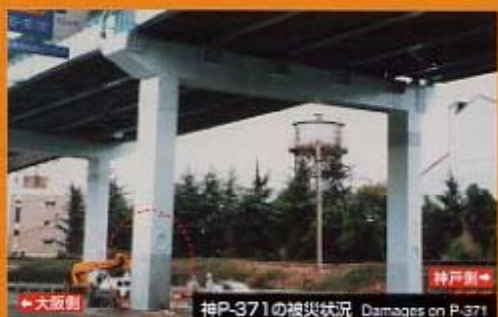
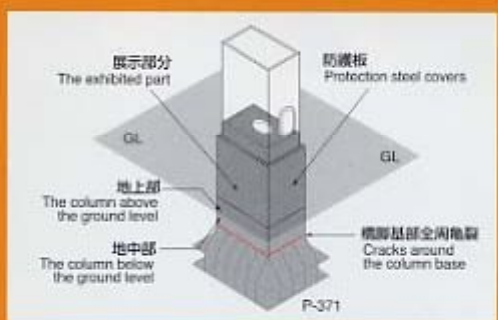
C-6 鋼製橋脚基部の亀裂

■ **損傷内容** / 山側橋脚柱基部(地中部)の補剛材上端において、ほぼ全周にわたる亀裂が生じた

■ **Damage descriptions** / Cracks occurred in the top end of the stiffeners at the base of the north pier which is located below the ground level. The cracks appeared almost all around the column.

■ **復旧方法** / 亀裂部を含む約5mの範囲を撤去し、新しい部材に取り替えた

■ **Restoration** / The portion in about 5 m length containing the cracks was removed out, and subsequently new members were installed.

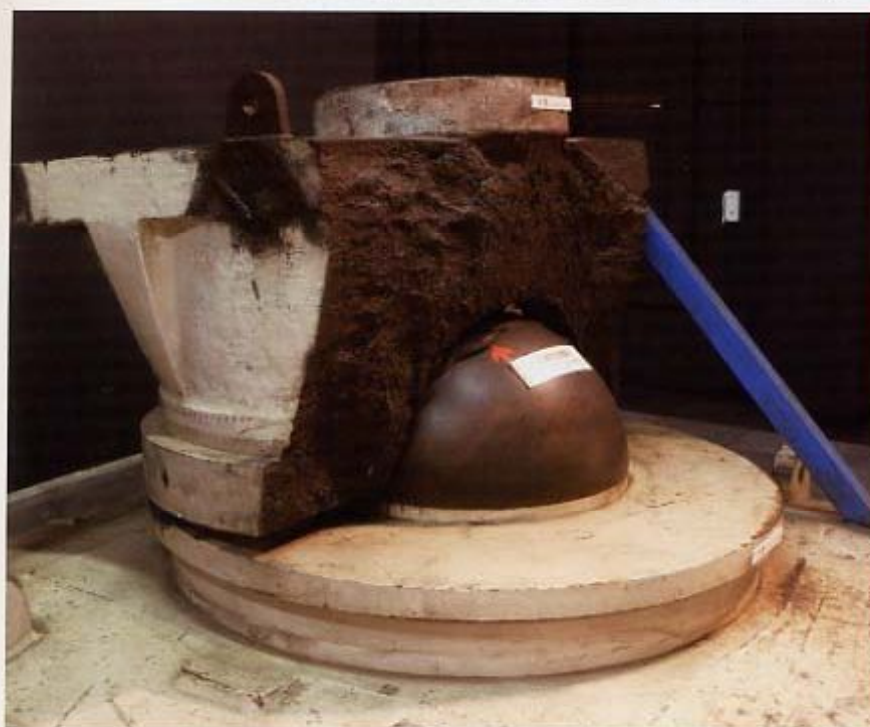
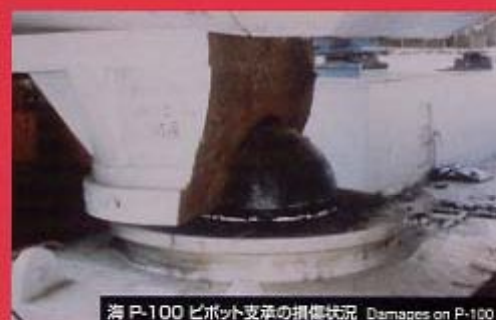
D-1 西宮港大橋におけるピボット支承の破損

海 P-100 ピボット支承の損傷状況 Damages on P-100

西宮港大橋は、5号湾岸線甲子園浜～西宮浜間の西宮航路をまたぐニールセンローゼ橋です。西宮浜側橋脚（海P-100）上において本橋を支持する2基のピボット支承（固定支承）のうち、山側支承の上着が半分に割れて落下しました。展示は、海P-100上に残ったピボット支承の下着および上着の半分と、甲子園浜側橋脚（海P-99）上の落橋した隣接桁を支持していたピボット支承です。

Nishinomiya-ko Bridge on Wangan Route (Route 5) is a 252 meters long Nielsen-Lohse arch bridge with steel decks linking two reclaimed lands in the Osaka Bay. The bridge is supported by fixed bearings on the east pier (Osaka side), and by movable bearings on the west pier (Kobe side). The bearings are all pivot type. Of the two fixed bearings, the one in the north (mountain side) suffered from brittle fracture on the upper shoe due to tremendous lateral seismic force. The upper shoe was fractured in half and the loosened part was dislodged from the pier.

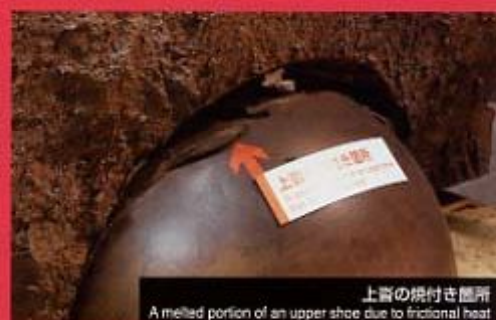
上着の焼付き箇所
A melted portion of an upper shoe due to frictional heat

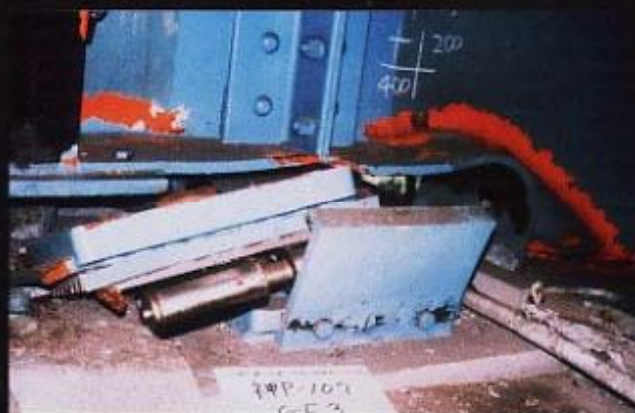
ローラー支承の上歯の逸脱
Deviation of upper shoe

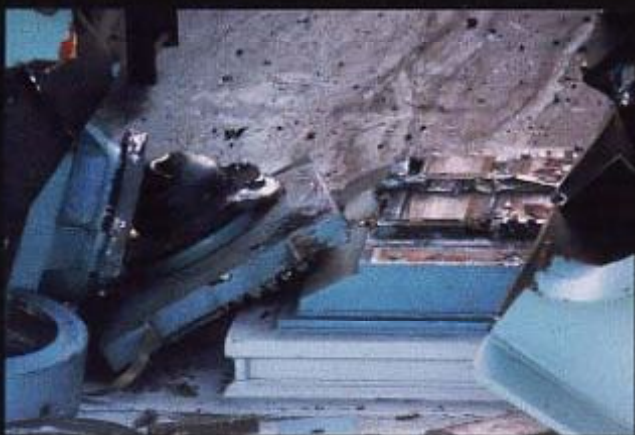
ピボットローラー支承の破壊
Failure of pivot roller bearing

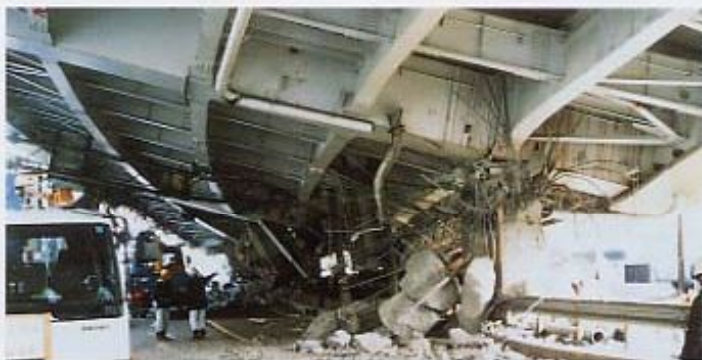
The Benten Viaduct in Hatobacho, Chuo-ku, Kobe, was seriously damaged in the earthquake. Multiple reinforced concrete piers failed in shear, causing the bridge to fall and the main girders buckle. The existing pile foundation was reused for faster restoration, with base isolators placed at the bottom of the piers so that no strengthening was required on the old foundation. High seismic performance is achieved in this new 19-span continuous rigid frame bridge with steel deck.
