# A-3 鋼連続箱桁橋の主桁の座屈

Buckling of continuous steel box girder

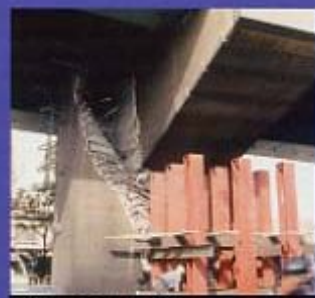
神P-240のせん断破壊 Damages on P-240

■**損傷内容**／①神S-238～240の上部工(3径間連続RC床版箱桁橋)を支持するRC橋脚4本のうち、固定橋脚の神P-240にせん断破壊が生じた②神P-240の橋脚位置のスレおよび沈下が生じた③上部工が、中間橋脚の神P-239および神P-240に近い側径間で主桁に大きな座屈が発生

■**Damage descriptions**／①The pier P-240 with a fixed bearing failed in shear among the four reinforced concrete piers which were supported the superstructure of the spans S-238 to S-240 (3-span continuous box girders with reinforced concrete decks).②The pier P-240 moved and sank from its original position.

■**復旧方法**／軽量化を図るため、3径間連続鋼床版箱桁橋を新たに製作し、新設した

■**Restoration**／ A new 3-span continuous box girder bridge was built with steel decks in order to reduce the weight of the superstructure.

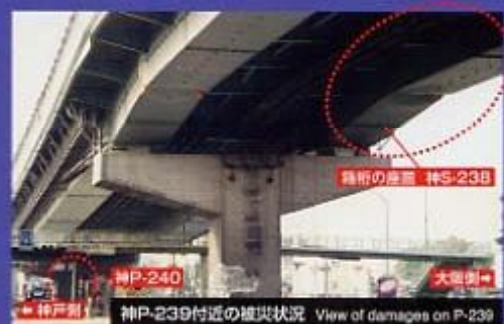
神P-239付近の被災状況 View of damages on P-239

③A significant buckling occurred in the main girders of the end spans at the regions closer to the intermediate piers (P-239 and P-240).
