震災資料保管庫

Hanshin Expressway Earthquake Museum

阪神高速道路の被害

Damage to the Hanshin Expressway

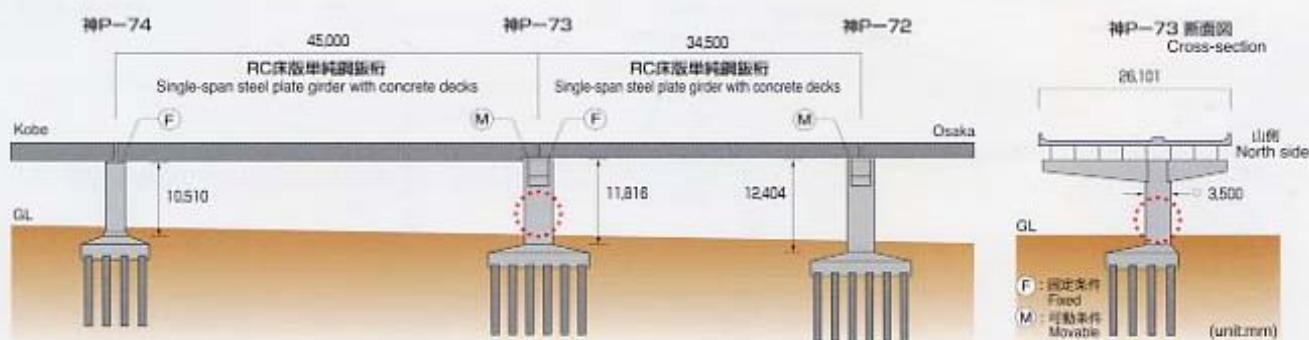
B-2 RC橋脚基部付近での曲げせん断破壊

Flexural shear failure around the base of reinforced concrete pier

■ 損傷内容 / 柱基部付近に一部主鉄筋が座屈する曲げせん断損傷を受け、また、神戸側および梁の張り出しが大きい山側へ柱が残留傾斜した

■ Damage descriptions / Flexural shear failure was occurred at the column base with the buckling of longitudinal reinforcement, and resulted in a residual inclination toward the east (Kobe side) and also toward the north in which direction the beam had large overhang.

■ Restoration / The damaged column was cut at the base and removed, and subsequently a new reinforced concrete rectangular column (3.9 m × 3.9 m) was built on site. Finally a factory-fabricated steel beam was connected on it to complete the pier.

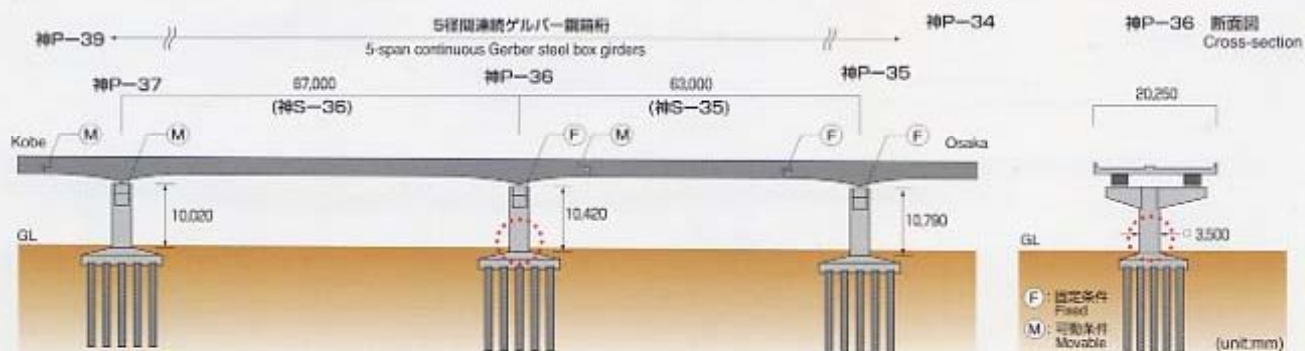
B-3 RC橋脚基部付近での曲げ破壊

Flexural failure around the base of reinforced concrete pier

■ **損傷内容** / 柱基部付近で、主鉄筋が全周にわたって座屈する激しい曲げ損傷が生じた

■ **Damage descriptions** / Serious flexural failure was occurred at the column base with the buckling of longitudinal reinforcements.

■ **Restoration** / The damaged column was cut at the base and removed, and subsequently a new reinforced concrete cylindrical column (diameter: 3.4 m) was built on site. Finally a factory-fabricated steel beam was connected on it to complete the pier.

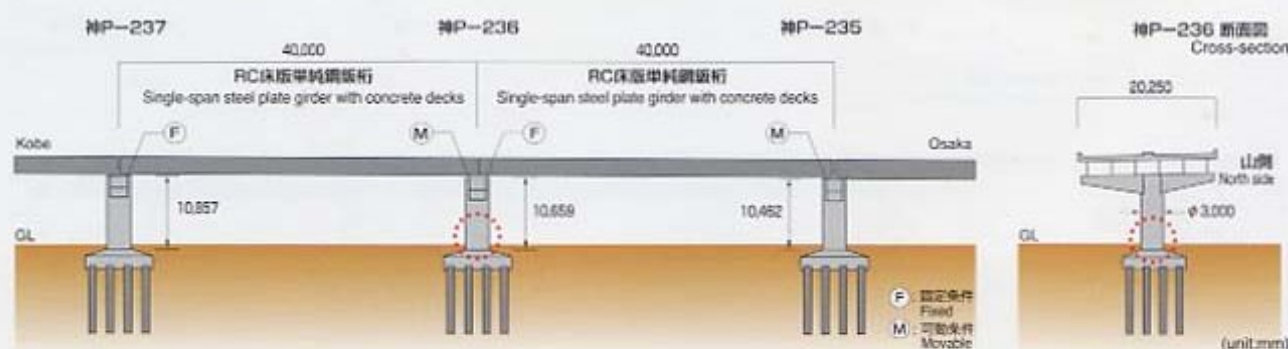
B-4 RC橋脚主鉄筋段落とし位置での曲げせん断破壊

Flexural shear failure of reinforced concrete pier at cut-off position of the main reinforcements

■ 損傷内容 / 柱高さ中央部の主鉄筋段落とし箇所付近において、主鉄筋が全周にわたって座屈する激しい曲げせん断破壊が生じた

■ Damage descriptions / Serious flexural shear failure was occurred at the around mid-height of the column where the longitudinal reinforcements had been cut off, causing the buckling of longitudinal reinforcement.

■ Restoration / The damaged column was cut at the base and removed, and subsequently a new reinforced concrete column (diameter: 2.9 m) was built on site. Finally a factory-fabricated steel beam was connected to it to complete the pier.

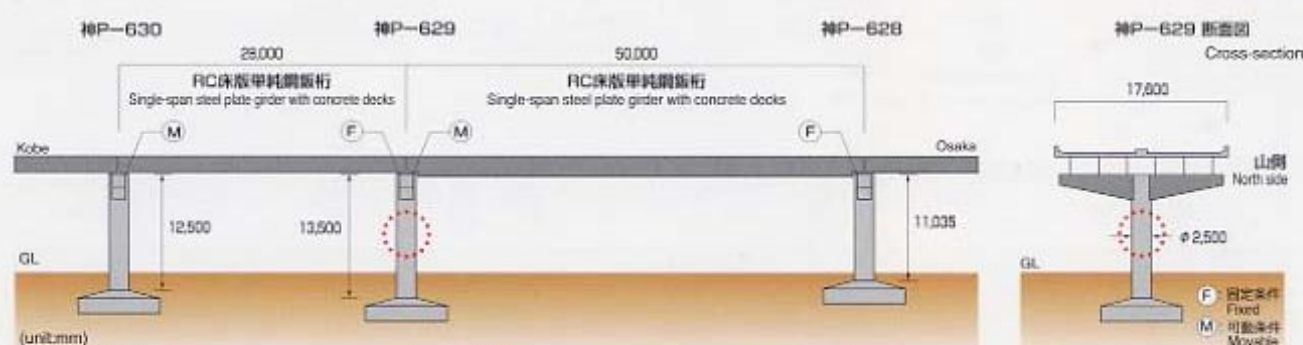
B-5 RC橋脚のせん断損傷

Shear damage of reinforced concrete pier

■ **損傷内容** / 柱基部よりやや上において、せん断損傷を受けた。外観調査では軽微な損傷と考えられていたが、詳細調査の結果、ひびわれが柱コンクリート内部にまで及んでいることが確認された

■ **Damage descriptions** / Shear failure was occurred in the column at a height slightly above its base. Although the column was determined as a minor damage during an appearance observation for the structure, it was found from a detailed inspection that cracks had reached the inner concrete of the column.

■ **Restoration** / The damaged column was cut at the base and removed, and subsequently a new reinforced concrete rectangular column (4.1 m x 5.1 m) was built on site. Finally a factory-fabricated steel beam was connected on it to complete the pier.

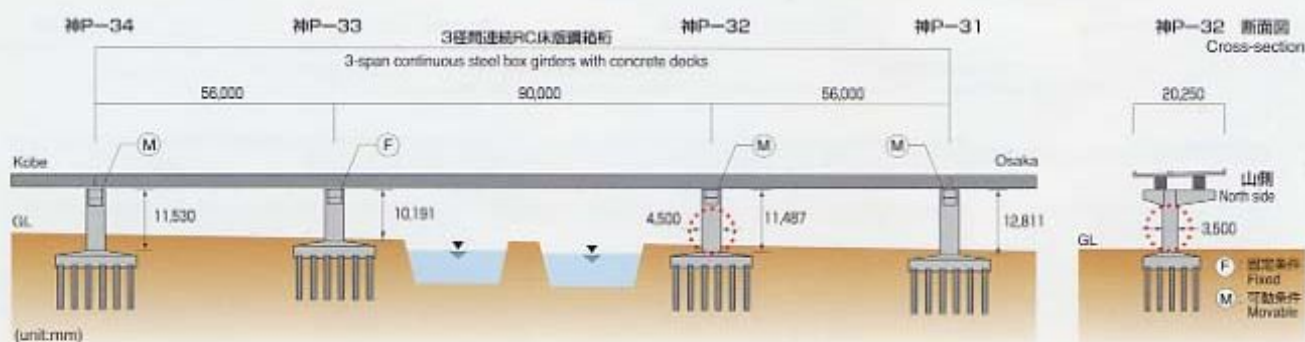
B-6 RC橋脚基部付近での曲げせん断破壊

Flexural shear failure around the base of reinforced concrete pier

■ 損傷内容 / 柱基部付近において、主鉄筋が全周にわたって座屈し、帯鉄筋がばらける激しい曲げせん断損傷が生じた

■ Damage descriptions / Severe flexural shear failure was occurred at the column base with the buckling of longitudinal reinforcement.

■ Restoration / The damaged column was cut at the base and removed, and subsequently a new reinforced concrete cylindrical column (diameter: 3.9 m) was built on site. Finally a factory-fabricated steel beam was connected on it to complete the pier.

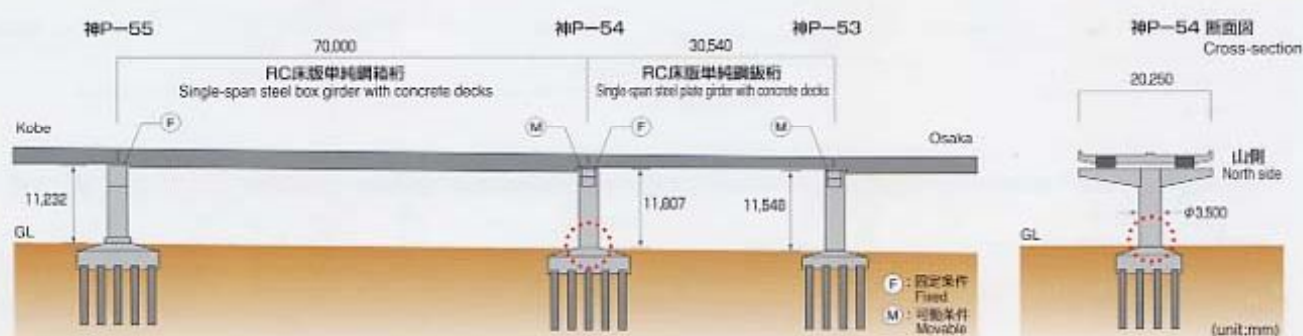
C-1 板パネルの局部座屈

Local buckling of stiffened plate of steel pier

■ **損傷内容** / 橋脚基部の中詰めコンクリートと直上の横補剛材間で板パネルの局部座屈が発生し、梁の張り出しが大きい海側に大きく傾斜した

■ **復旧方法** / 上部工および橋脚梁部を仮受けした後、損傷した橋脚基部を切断・撤去し、新しい部材(板厚30mm、材質SM490YB)と取り替えた。また、橋脚内部の中詰めコンクリートの設置範囲を従来より高くした

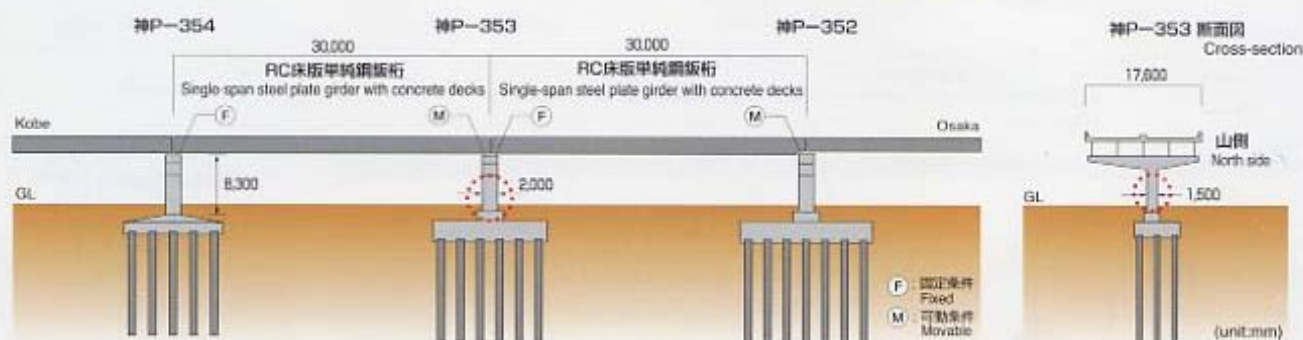
C-2 鋼製橋脚(円形)のわれ

Cracks in circular steel pier

■**損傷内容**／外観上座層はほとんど認められなかったが、横補剛材間の溶接部全周にわれが発生していた

■**Damage descriptions**／ Although almost no buckling was visible from the appearance, cracks were found in the welds between lateral diaphragms all around the pier.

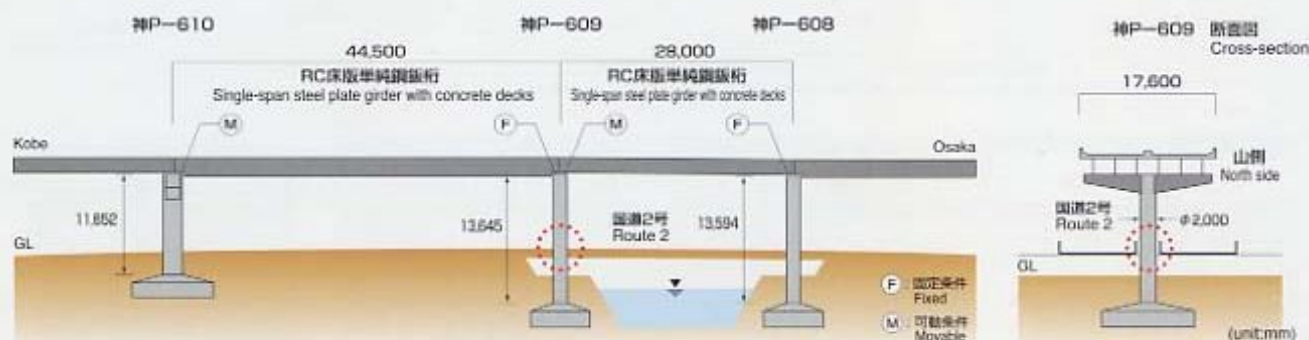
C-3 鋼製橋脚(円形)の局部座屈・われ

Local buckling and cracking in circular steel pier

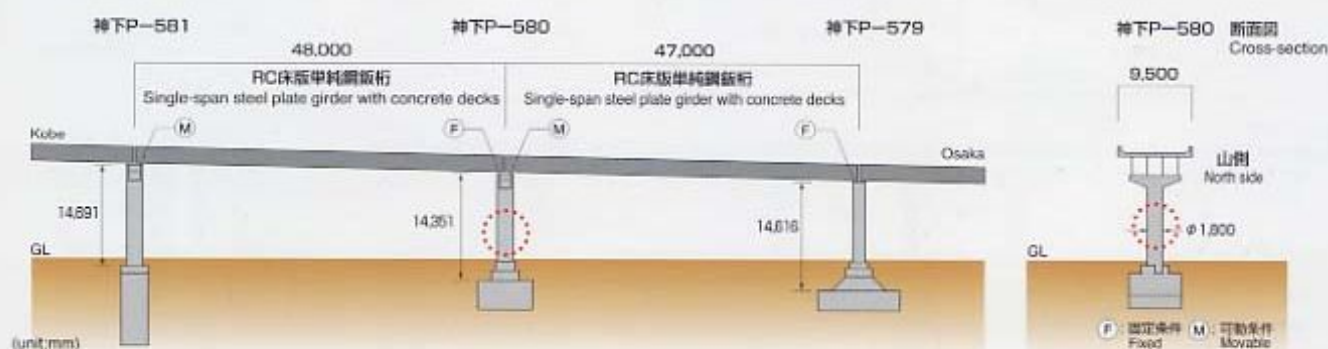
C-4 鋼製橋脚(円形)の局部座屈・破断われ

Local buckling and tension cracks in circular steel pier

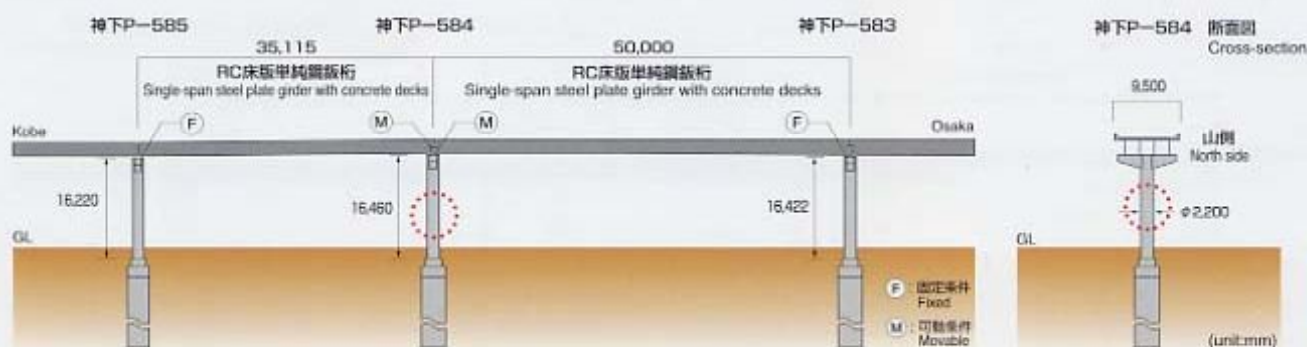
C-5 縦補剛材の座屈

Buckling of stiffeners in steel pier

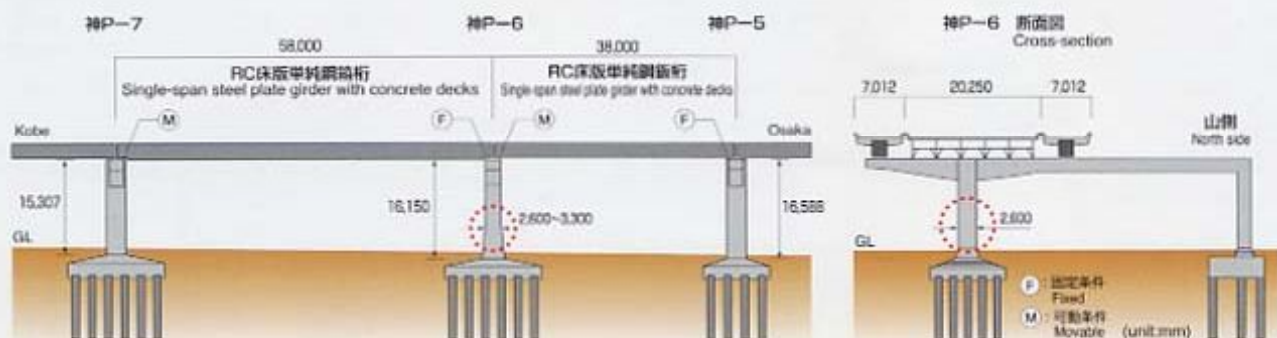
C-6 鋼製橋脚基部の亀裂

Cracking at the base of steel pier

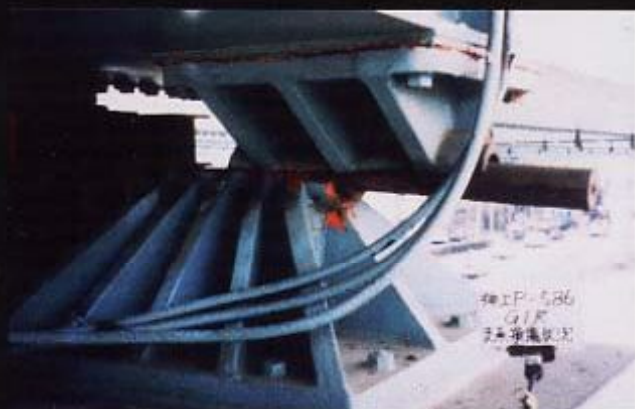
ピン支承の抜け出し
Excessive pin displacement

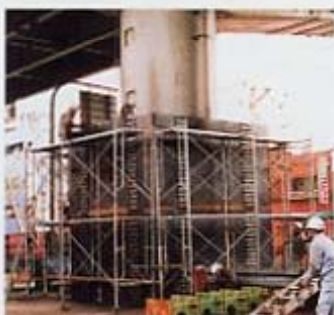
RC橋脚の2次災害防止のための応急補強
Emergency strengthening on a reinforced concrete pier for secondary disaster prevention

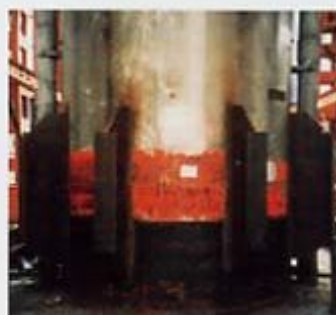
鋼製橋脚の2次災害防止のための応急補強
Emergency strengthening on a steel pier for secondary disaster prevention

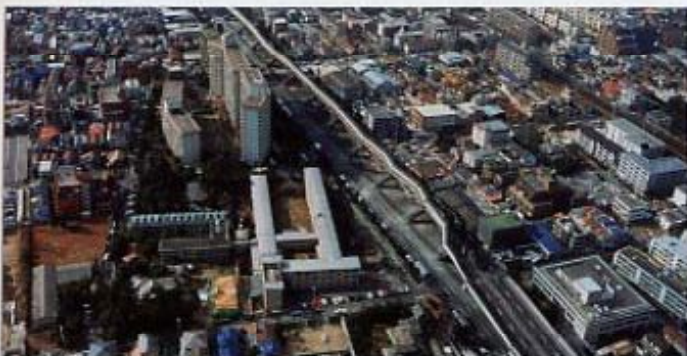
An 18-span prestressed concrete bridge collapsed for a length of 635 m in Fukae Honmachi, Higashinada-ku, Kobe. This section had a Pilz or mushroom-shaped structure in which the bridge piers and girders were rigidly connected to each other, with the mid-span girders suspended. The girders fell northward in the earthquake as 17 reinforced concrete piers collapsed at mid-height of the columns.

震災直後 Immediately after the earthquake

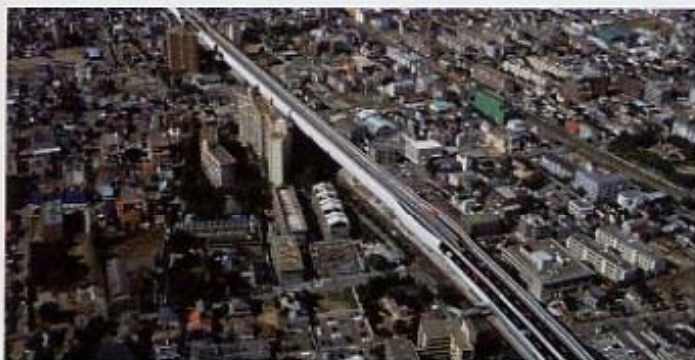
復旧後 Restored bridge

The piers and girders of the rebuilt structure are no longer connected to each other, with base isolators installed for a reduced seismic load. The dual box girders with steel deck are light in weight, and the reinforced concrete piers have expanded widths in the transverse direction.
